Maroochydore Beach Nourishment Project Evaluation

August 2016

<p>BMT WBM Pty Ltd Level 8, 200 Creek Street Brisbane Qld 4000 Australia PO Box 203, Spring Hill 4004</p> <p>Tel: +61 7 3831 6744 Fax: + 61 7 3832 3627</p> <p>ABN 54 010 830 421</p> <p>www.bmtwbm.com.au</p>	Document:	R.B21974.001.01.evaluation.docx
	Title:	Maroochydore Beach Nourishment Project Evaluation
	Project Manager:	Matthew Barnes
	Author:	Matthew Barnes and Jeremy Visser
	Client:	Sunshine Coast Council
	Client Contact:	Michael Anderson
	Client Reference:	
Synopsis: A summary and evaluation of the Maroochydore Beach Nourishment Project

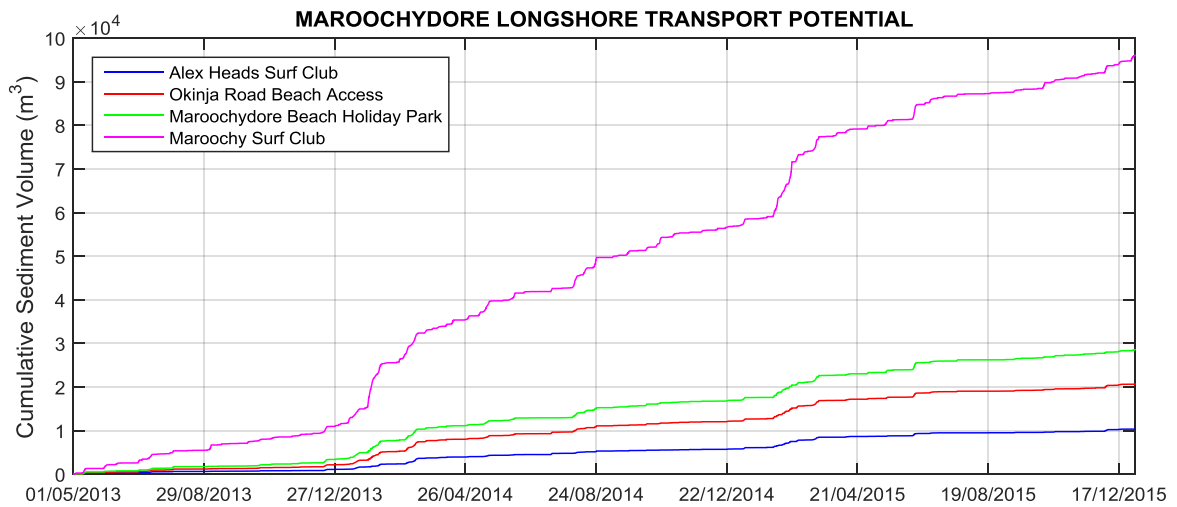
Figure 4-9 Cumulative Volume of Longshore Sediment Transport

The net and gross wave-driven longshore sediment transport between Alexandra Heads and Maroochy Surf Clubs was calculated using the CERC equation and the estimated inshore wave climate. Figure 4-9 shows the cumulative longshore sediment transport volume for the Project period (positive gradient is in the northerly direction). It is noted that the reported transport rates represent transport potentials. Actual sand transport rates may be restricted by the availability of sand. For example, at locations where exposed coffee rock exists on the beach or in surf zone from time to time, the actual longshore sand transport rates may be smaller than those predicted. Results of the longshore sediment transport modelling are summarised below:

- Between October 2013 and April 2014 approximately 50% of the placed sand was moved from upper beach to a location seaward of the survey limits. During this period the beach profile adjusted from the 'constructed' condition toward a theoretical equilibrium with the prevailing coastal processes. This sand was not lost from the beach system but rather relocated from the upper beach to the nearshore (or 'surf zone') area. The cross-shore transport estimates provided in Table 4-4 suggest erosion conditions were dominant during January, February and March 2014. A steep gradient in longshore sediment transport to the north was also estimated during these months (see Figure 4-9).

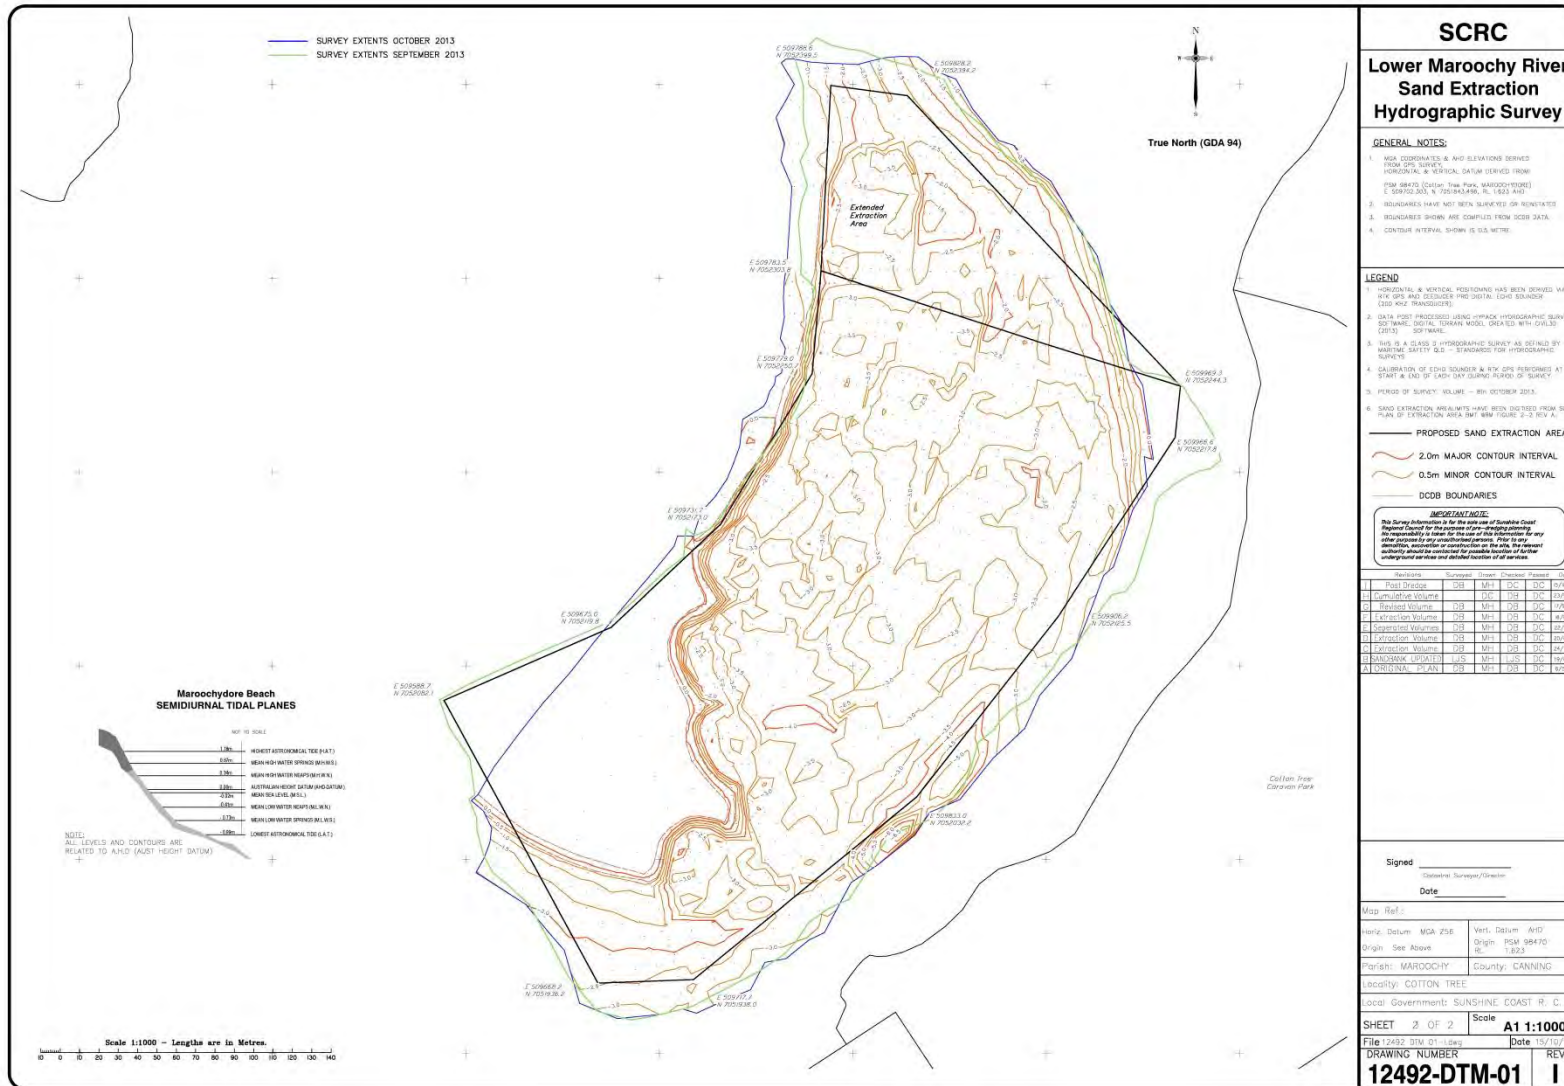
Figure 5-1 Stage 1 Post Works Sand Extraction Survey October 2013

The Stage 1 post-works hydrographic survey of the permitted sand extraction area is shown in Figure 5-1. Throughout this area sand was dredged to an average elevation of -3.0 mAHD, corresponding to a sand volume of approximately 125,000 m³.
