***LAKE CURRIMUNDI DYNAMICS STUDY***  
***Volume 2 : Appendices***

**Griffith Centre for Coastal Management  
Research Report No. 75**

January 2010

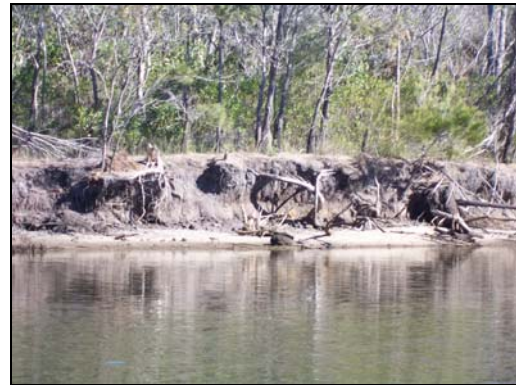
### ***Bank Erosion***

Increasing bank erosion is of concern not only due to the loss of bank vegetation and parkland but also due to the introduction of sediment into the system.

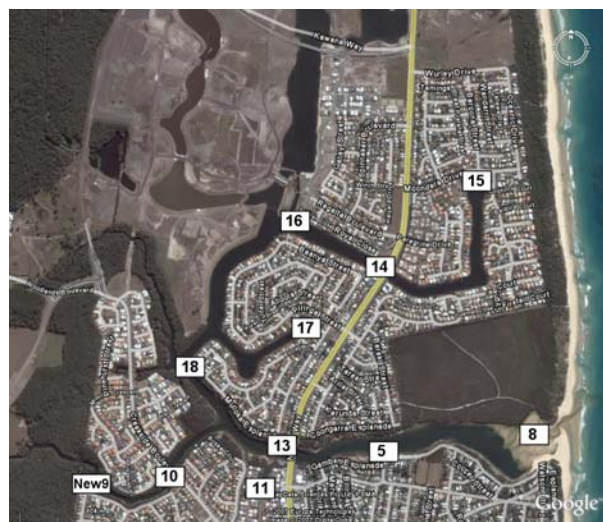
Caloundra City Council have taken monthly measurements of water quality indicators in the Currimundi Lake system and associated canals, since 2001. These indicators include temperature, dissolved oxygen (mg per L and %), pH (acidity), conductivity, salinity, faecal coliforms, nutrients (ammonia, nitrogen oxides, reactive phosphorus, total phosphorus), turbidity and suspended solids.

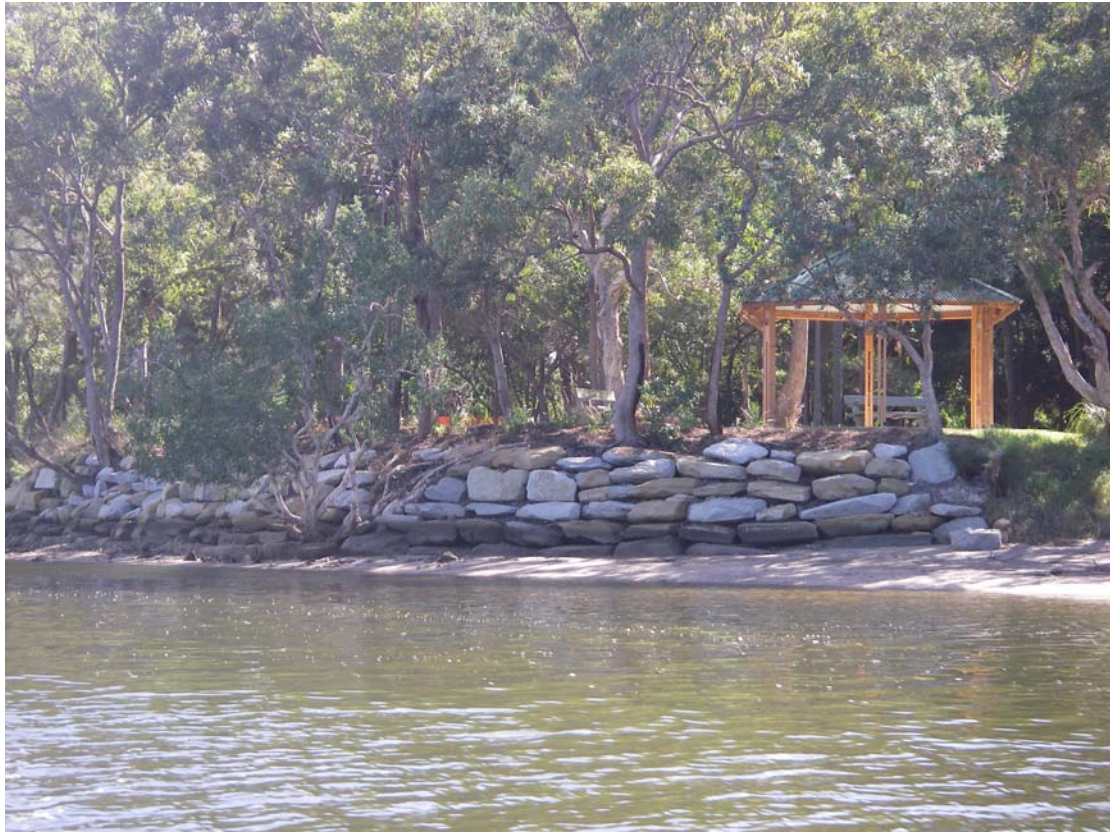
**Figure A5.5: Example of Rock Wall**

In addition to the rip-rap discussed in the previous section larger rocks similar to that shown in Figure A5.5 can be used.

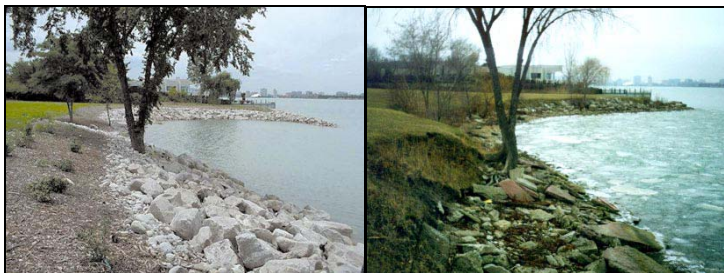
<sup>1</sup>Rip Rap (Source: Caulk *et al.*, 2000).

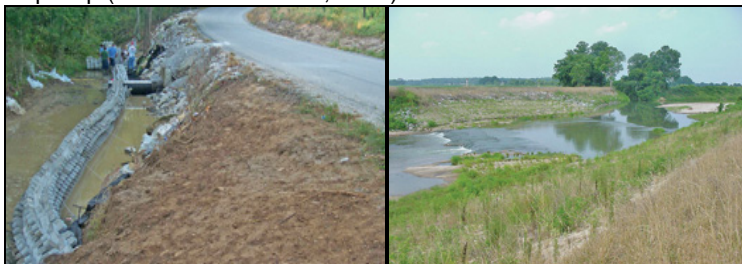
<sup>3</sup>A-jacks (Source: Unknown)

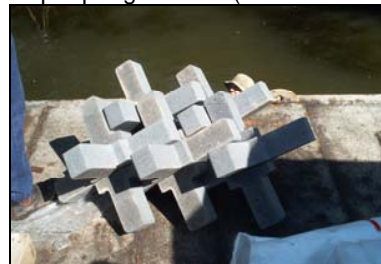
<sup>3</sup>A-jacks (Source: GCCC)

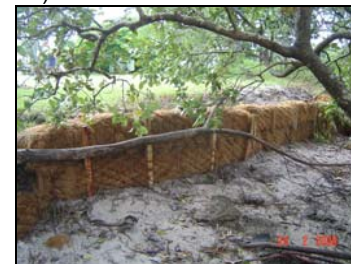
<sup>4</sup>Coir logs (Source: GCCC)

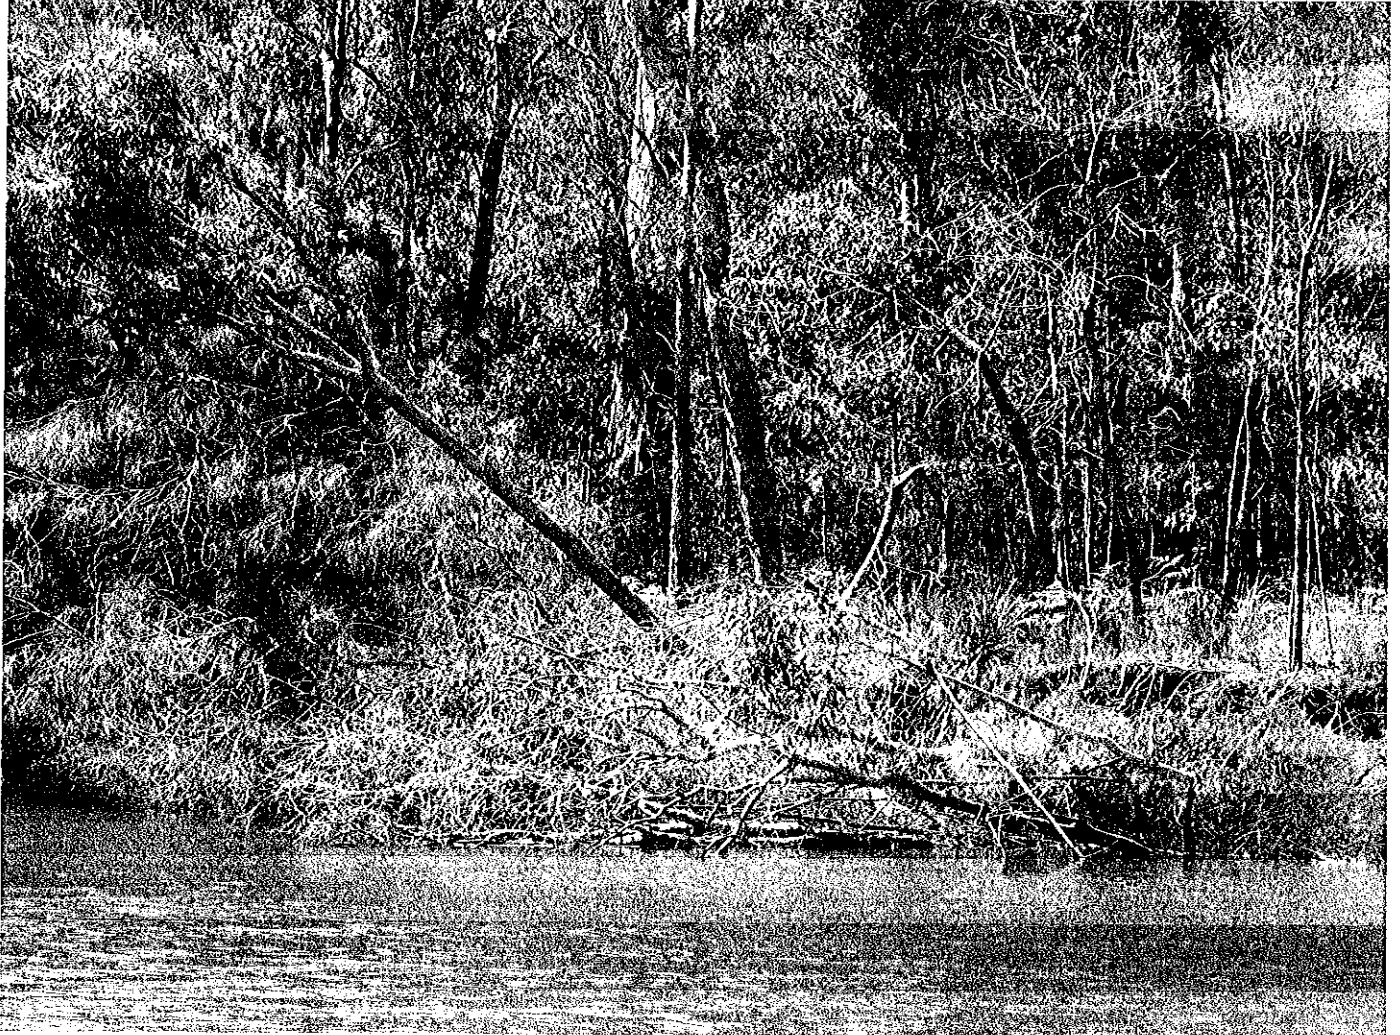
Wash from boats is continuing to undermine the banks. The tree shown below is now doomed, and another much larger tree about 30 meters upstream will be next.

In the above photo, note the tree about to fall, and the larger amount of soil and smaller trees, that has already fallen into the water.

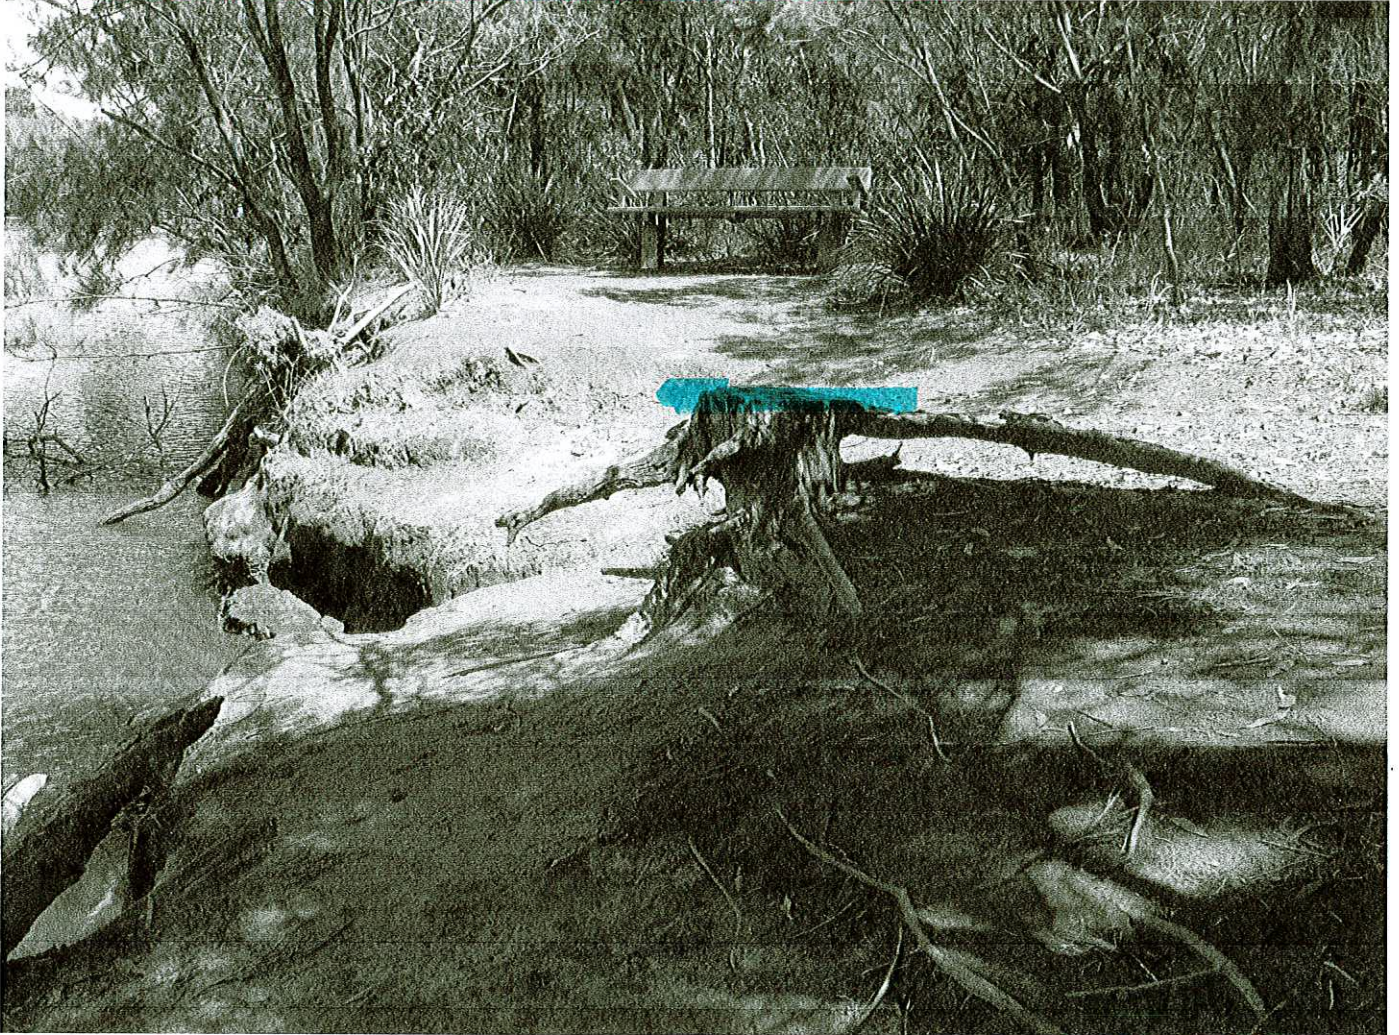
There are a couple of sites where sheet erosion is taking place, in particular the ground near the “Old jumping tree” opposite Dewrang Place, and at the western end of the park adjacent to the end of the canal.

The recent rain has increased the erosion, and coupled with increased pedestrian traffic over the Christmas season, has made the repair and prevention of this erosion an urgent matter.

Note how the stump in the center of this picture is now way above ground level. The point at which the trunk was cut off was once the ground level. The ground was more or less level from foreground to the seat. Many tones of soil have been eroded, and the grade of the remaining ground will ensure a more rapid rate of erosion from both water run off, and pedestrian traffic.
